STATE OF WASHINGTON
DEPARTMENT OF ECOLOGY

Re: Milestone 4 Source Control Status Report for Head of Hylebos Waterway
Problem Area: Commencement Bay Nearshore/Tideflats Superfund Site

Milestone 4: Administrative Actions in Place for All Sources

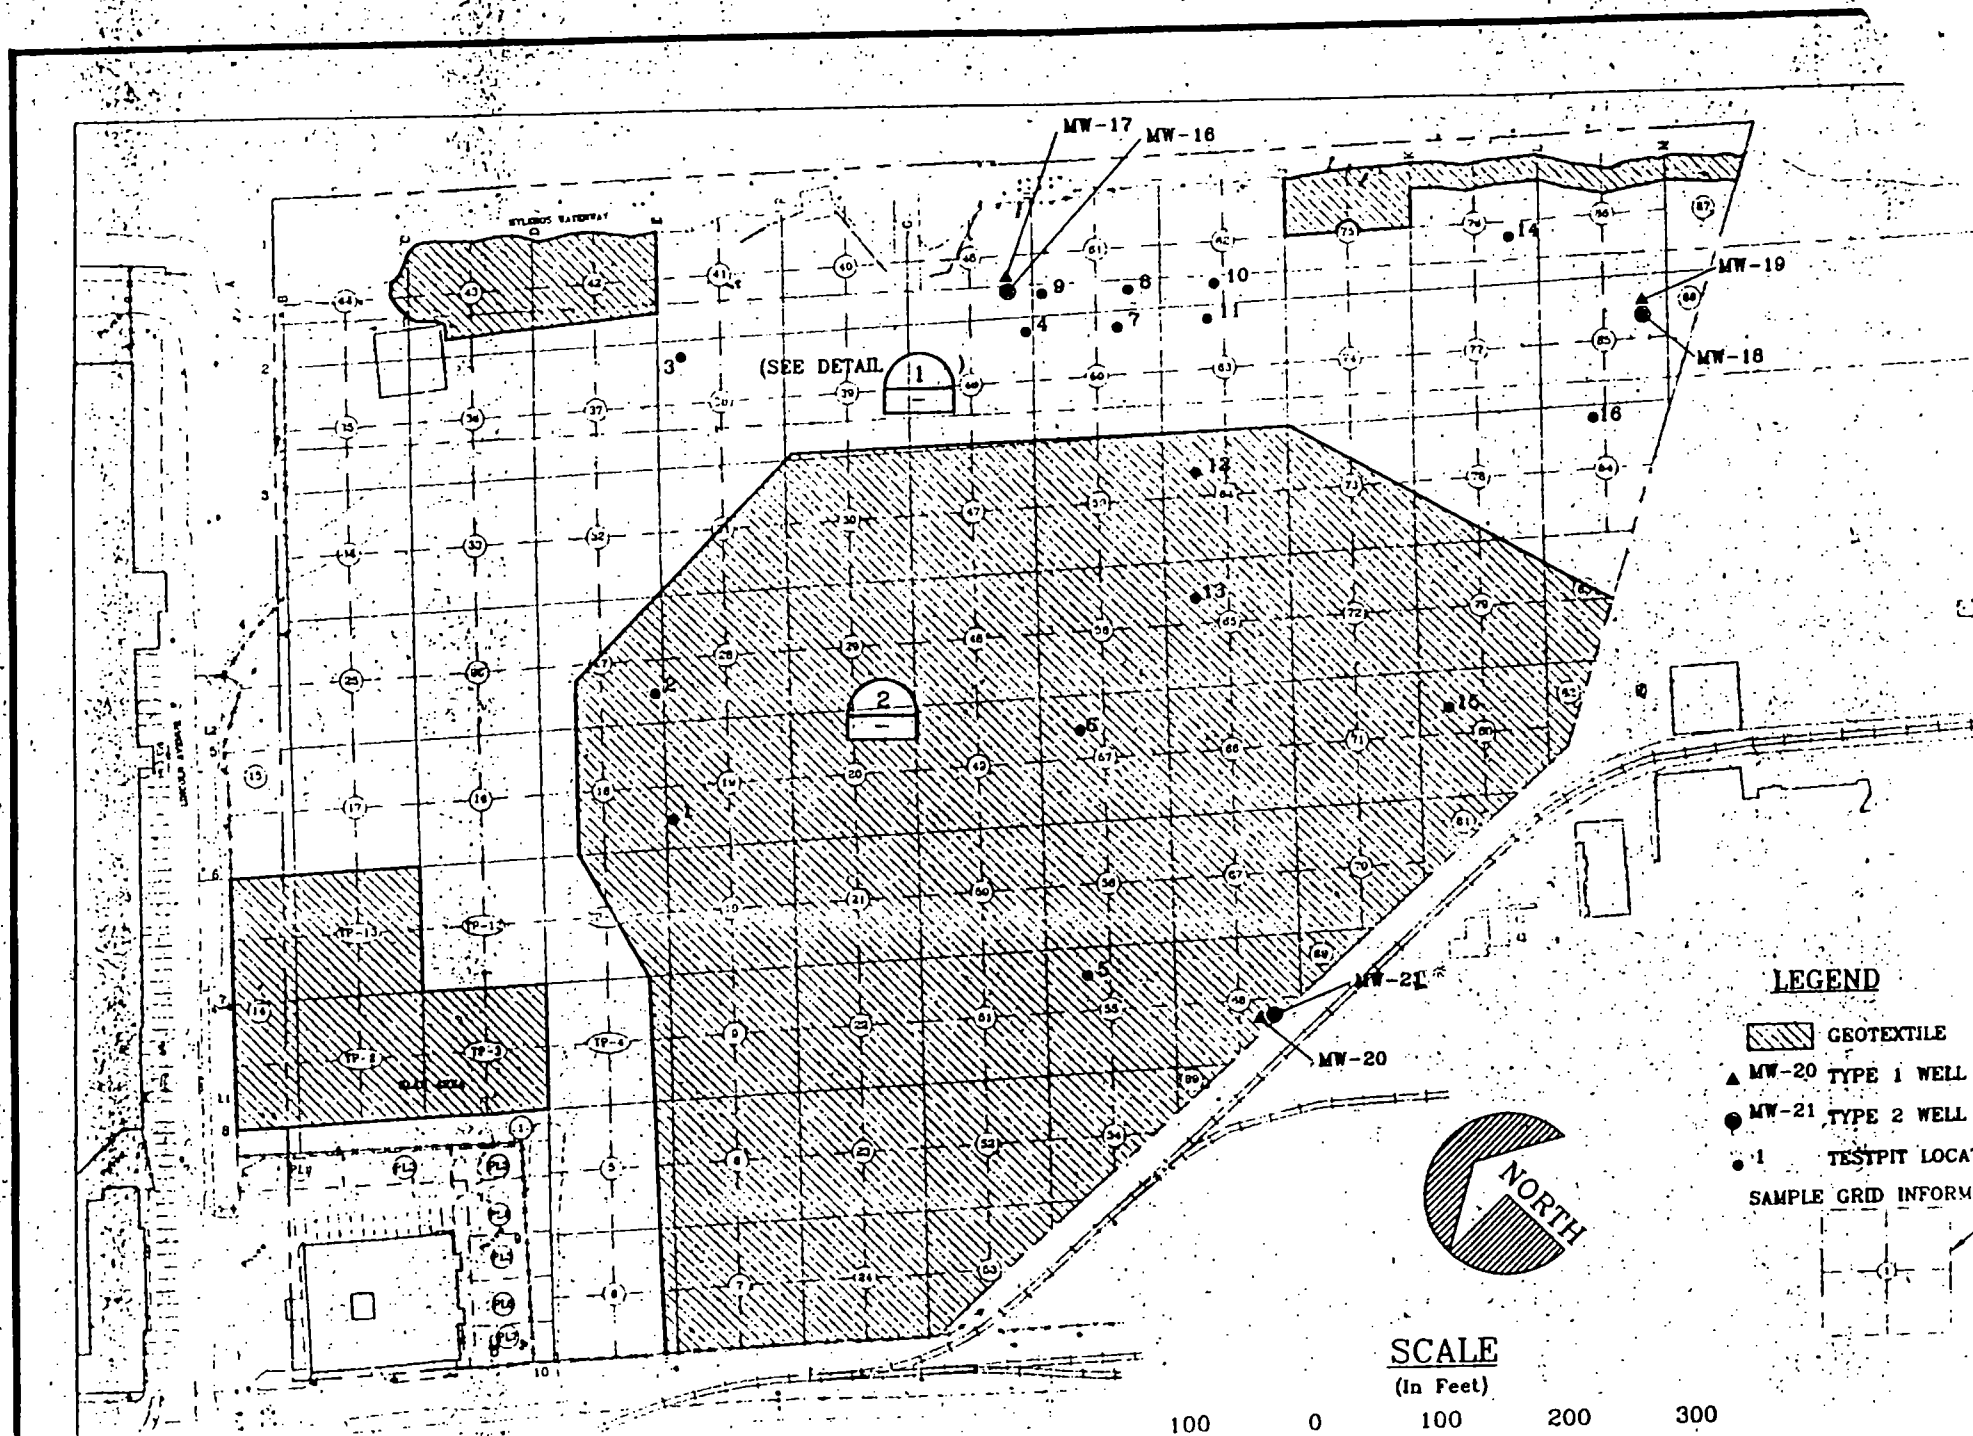
Murray Pacific

Well Map, Post-Cleanup Groundwater Data (Shenk and Associates, 1998), and Map Showing Limit of Intertidal Remedial Excavation (Hydrometrics, 1996)

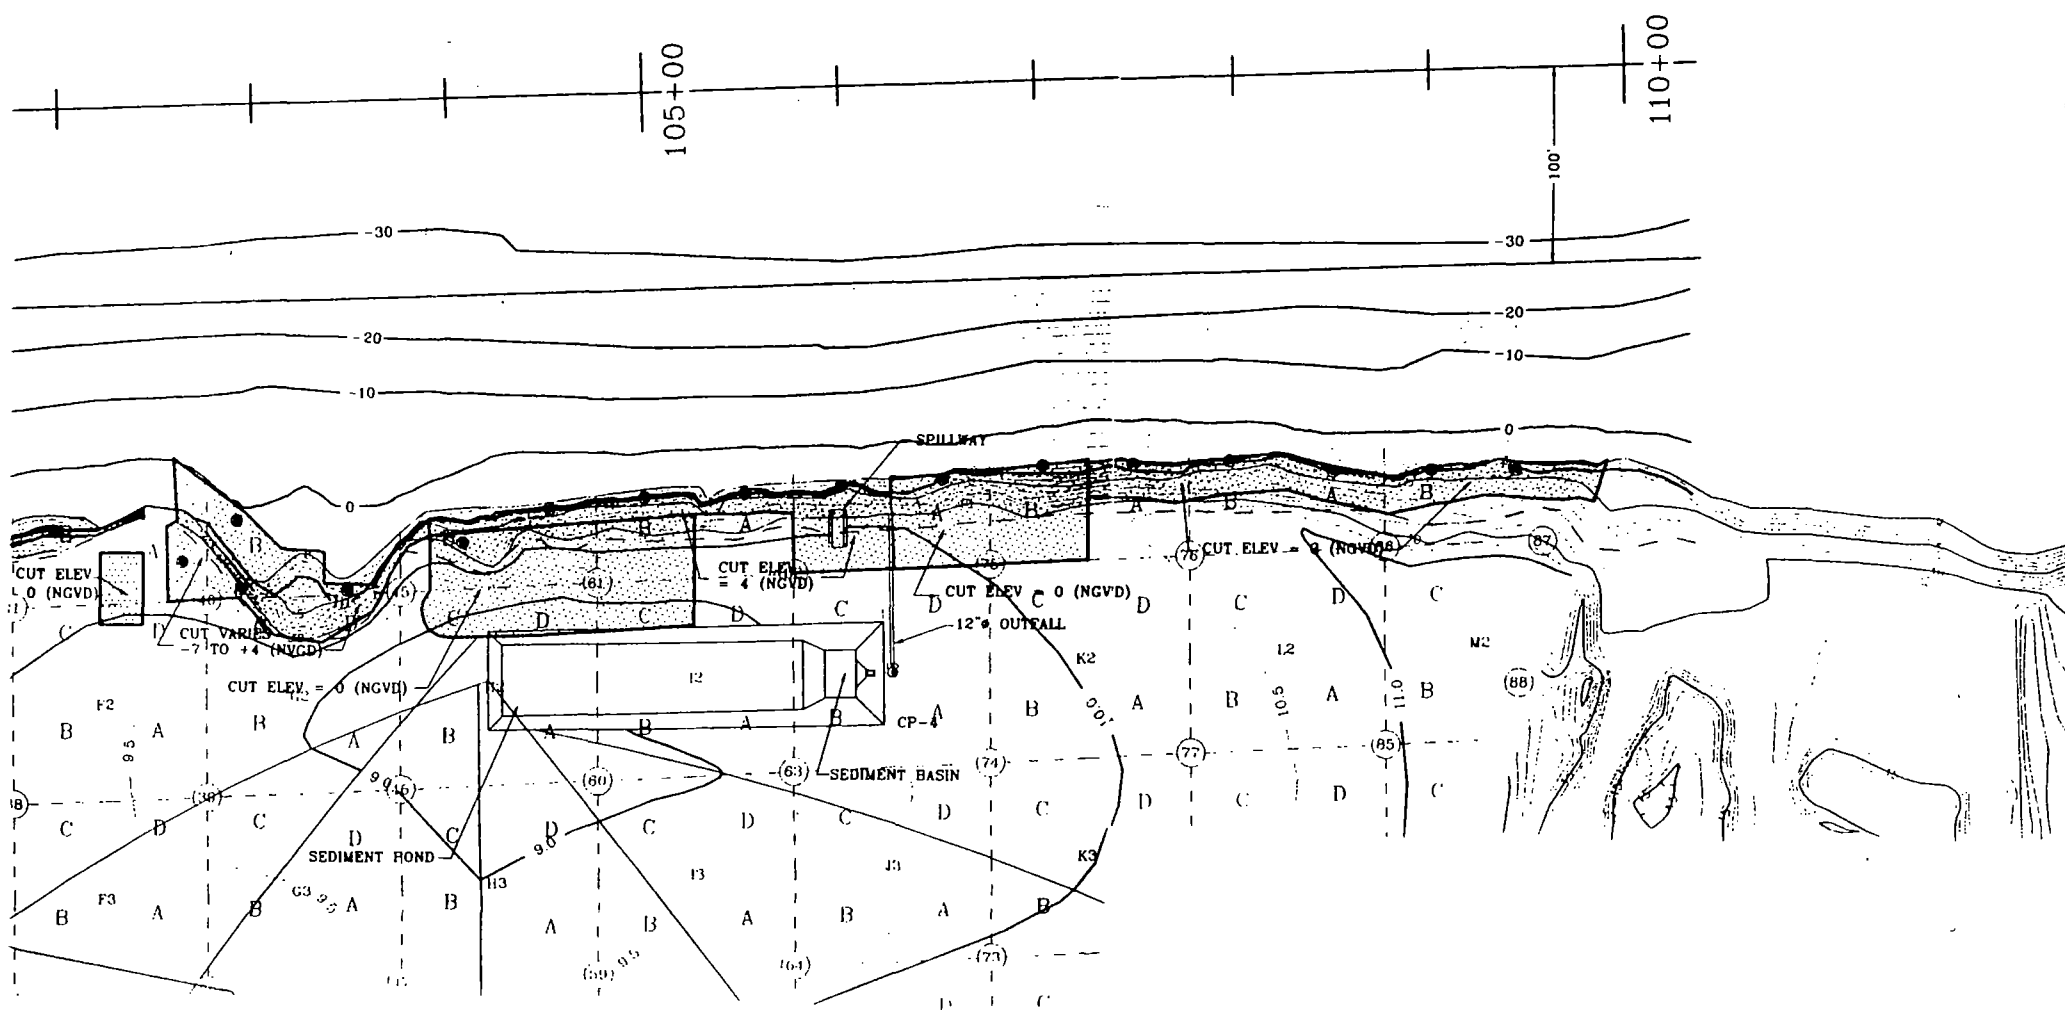
MURRAY PACIFIC YARD #1 MONITORING WELL DATA

(D) = deep marine sediment well: MW-16 screened at 15-20 feet; MW-18 screened at 17.5-22.5 feet; MW-21 screened at 25-30 feet.

(S) = shallow dredge fill well: MW-17 screened at 7-11 feet; MW-19 screened at 5-10 feet; MW-20 screened at 5-9 feet.

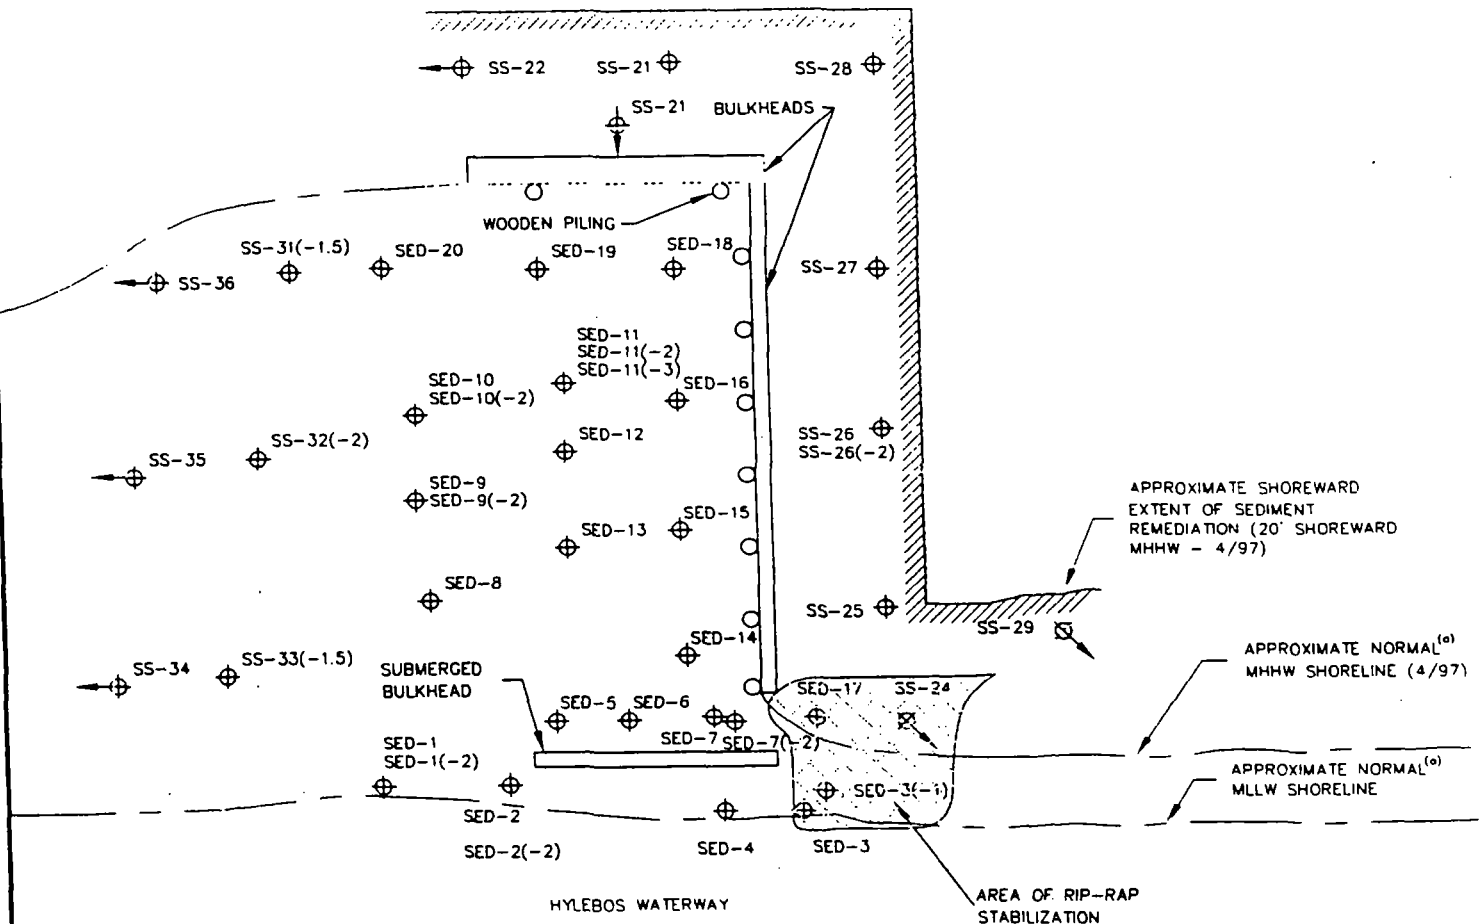
Don Oline Site

(a) PRIOR TO ANY SITE EXCAVATION/REMEDIATION
